Mazda 6: Head Unit Modification (L716 jumper)

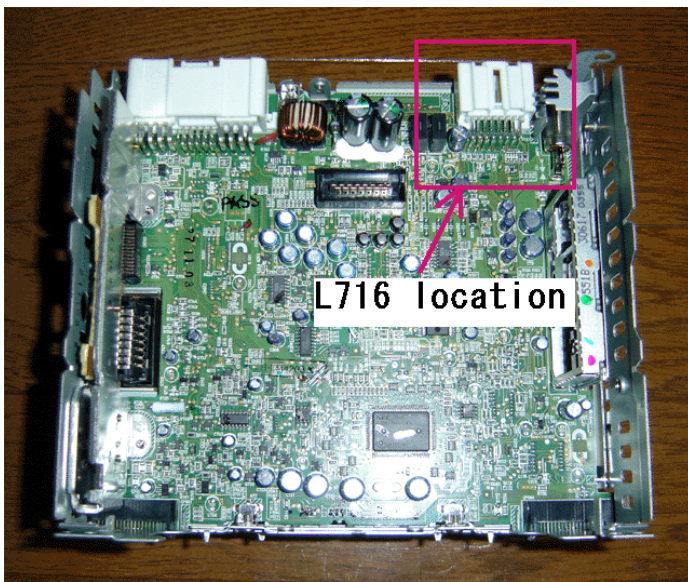
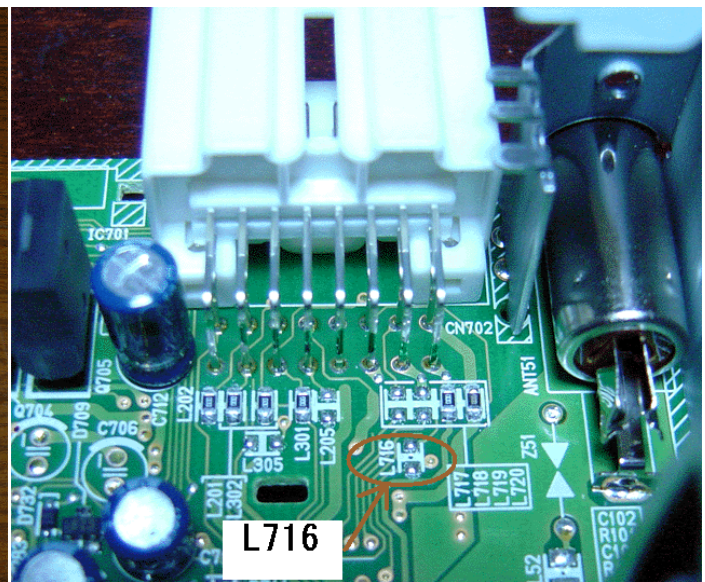
Locating the L716 jumper

There are at least two versions of Panasonic (Matsusita) head unit on the market. If your Mazda6 stereo is manufactured in 2003 - 2005 then the chances are that your head unit will not recognize Xcarlink. This is because newer head units do not have the zero ohm register on the PCB location L716. To solve this problem, you must take the head unit out, open the head unit (it voids warranty) and solder a Jumper or a 0-ohm chip register on location L716.

Bridge L716 soldering pads with thin wire and be careful not to short other circuits
